# Deviation From Design

**DfD : DfD-0002**

**Taran Laval – SAAA Builder 7417  
Van's Aircraft RV7 - 73918**

## **Horizontal Stabiliser Front Spar – Elongated Holes**

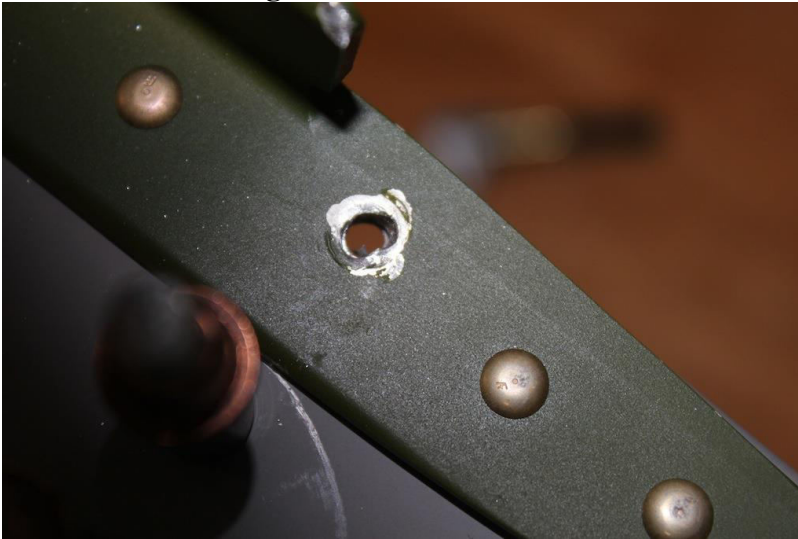
During the riveting of HS405 & HS404 ribs to the Fwd Spar of the Horizontal Stabiliser one hole in which rivets had been removed from that attaches the HS405-HS702-HS714 became elongated.

Van's Technical Support were contacted and advised to move up to the next rivet size and that I had to determine my own length.

The hole was drilled out to a 5/32" size and a BACR15BB5AD6.5 (Interchangeable with AN470AD5-6.5) rivet was installed.
