# Deviation From Design

**DfD : DfD-0005**

**Taran Laval – SAAA Builder 7417  
Van's Aircraft RV7 - 73918**

## **RH HS404-HS710-HS405 Hole Elongation**

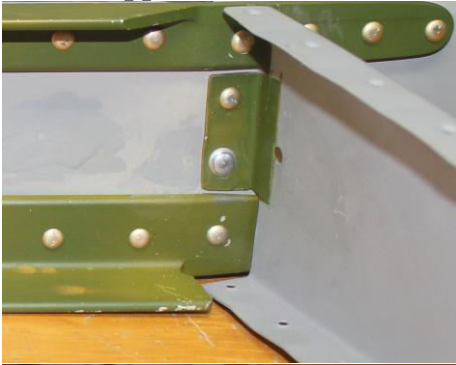
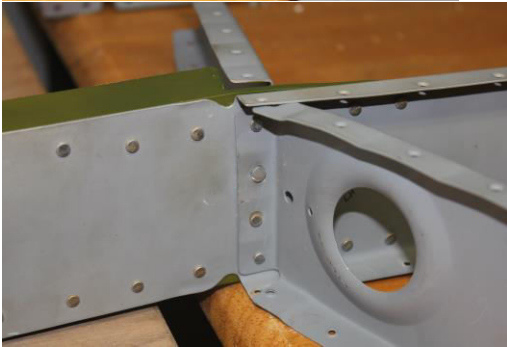
**During removal of the RH HS404 the upper rivet hole become elongated.**

**Drilled upper RH HS404 hole to 5/32 and installed a – 5 rivet.**
