# Deviation From Design

**DfD : DfD-0006**

**Taran Laval – SAAA Builder 7417  
Van's Aircraft RV7 - 73918**

## **RHS VS Skin Mid Mis-Dimple**

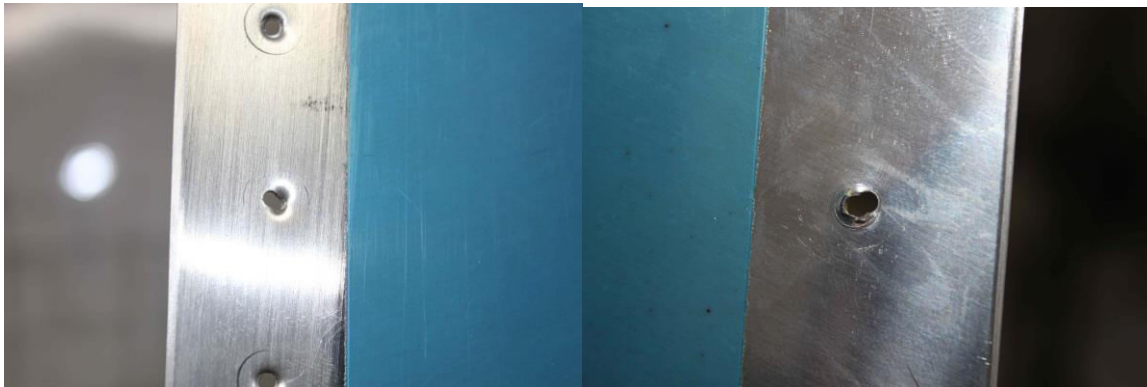
During Dimpling of the Vertical Stabiliser one of the holes midway up the aft edge of the right hand side of the Vertical Stabiliser became elongated after the dimple die was actuated while not properly set.

Van's Aircraft Technical Support were contacted and advised to:

*“go to the next size rivet up to fill this slightly larger hole, also an oops rivet can be used in small quantities when building.”*
