# Deviation From Design

DfD : **DfD-0007**

**Taran Laval – SAAA Builder 7417**  
**Van's Aircraft RV7 - 73918**

## **RHS VS Skin Upper Fwd Mis-Dimple**

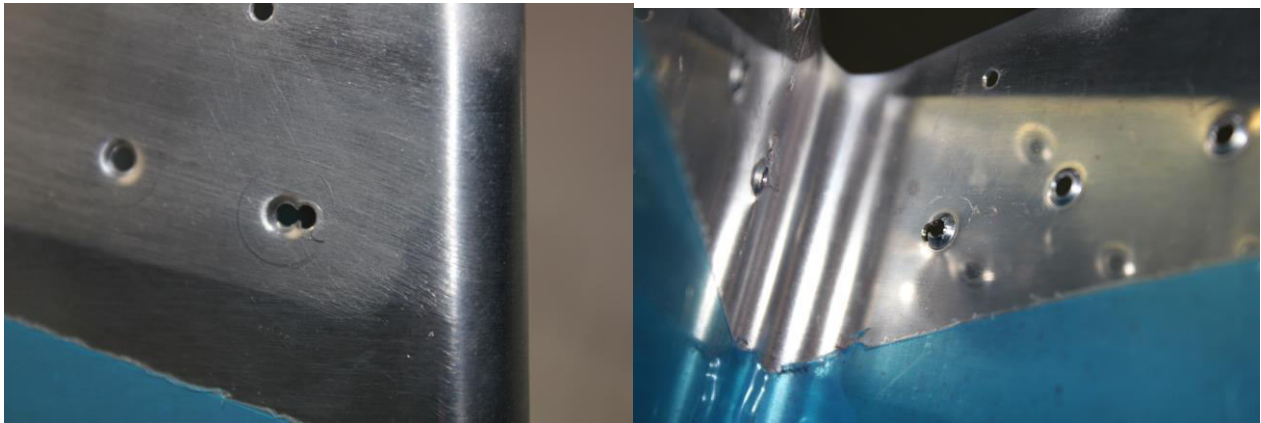
During Dimpling of the Vertical Stabiliser one of the holes on the upper fwd edge of the right hand side of the Vertical Stabiliser became elongated after the dimple die was actuated while not properly set

Van's Aircraft Technical Support were contacted and advised to:

*“For the figure eight hole where you almost completely missed the actual hole you can try flattening out the miss dimple and just going on like normal. I have heard of people filling the void with "JB" weld to give it a little added structure. A nother option is to abaddon that hole and put two new ones in, one to ether side of the one you skip. If you are worried about structural integrity or just don't want people to see an extra dimple in the middle of no where there is always the option of new parts.”*
