# Deviation From Design

DfD : **DfD-0012**

**Taran Laval – SAAA Builder 7417  
Van's Aircraft RV7 - 73918**

## **RUDDER FWD COUNTERBALANCE ASSY RIVET ISSUE**

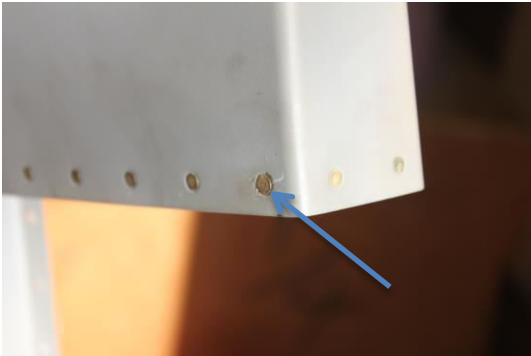
**WHILE RIVETING FWD RHS OF COUNTERBALANCE SKIN TO RIB A HOLE  
BECAME ELONGATED**

INSTALLED AN NAS109AD4-4 (OOPS) RIVET,  
BECAUSE OF THIS RIVET INSTALLATION MATERIAL FROM THE COUNTERBALANCE HAD TO BE  
REMOVED, 838g DOWN TO 830g (NEGLIGABLE AMOUNT) & COUNTERBALANCE WAS REPRIMED.
