# Deviation From Design

| DfD : | DfD-0018 | Follow Up<br>Required | Taran Laval – SAAA Builder 7417<br>Van’s Aircraft RV7 - 73918 |
| LH ELEVATOR TRIM TAB OB RIB EDGE DISTANCE | | | |

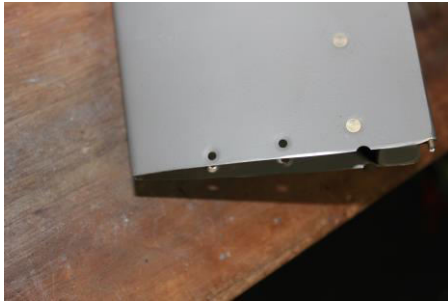
WHEN CUTTING THE OB EDGE OF THE TRIM TAB AS PER MOD-001 THE EDGE WAS NOT CUT 90° TO THE SPAR AS REQUIRED, WHEN THE TRIM TAB WAS TRIAL FITTED TO THE ELEVATOR THIS ISSUE WAS PICKED UP & TAB WAS TRIMMED ACCORDINGLY, THIS TRIMMING OPERATION COMPROMISED THE EDGE DISTANCE FOR ONE OF THE OB RIB RIVETS FROM THE STANDARD PRACTISES REQUIRED 2x DIA OF 3/16" DOWN TO 1/8" – 1/16"BELOW STANDARD PRACTISES MINIMUM.

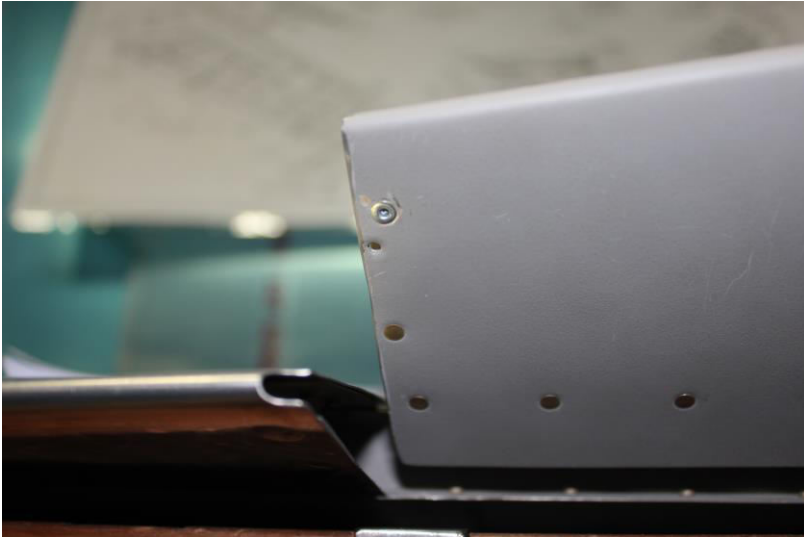
I don't see anything wrong with what you have done in the picture.

FLATTENED DIMPLE & DRILLED NEW RIVET HOLE, WILL FILL OLD HOLE LATER

UNUSED HOLE TO BE INSPECTED PERIODICALLY FOR EVIDENCE OF CRACKING
