# Deviation From Design

**DfD-0020**

**Taran Laval – SAAA Builder 7417  
Van's Aircraft RV7 - 73918**

## **LH WING MAIN RIB TO FWD SPAR DAMAGE**

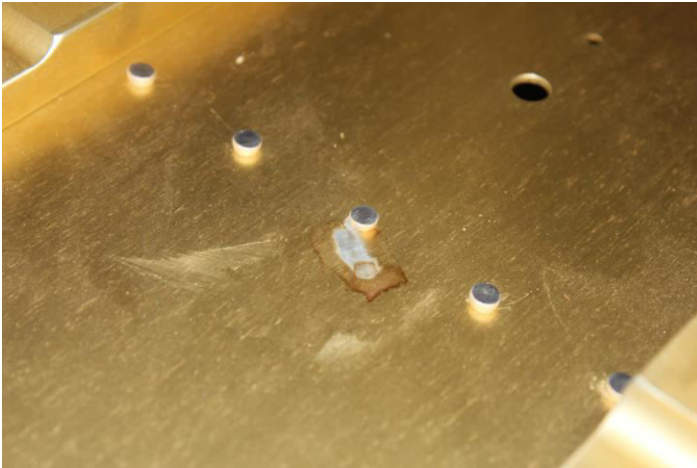
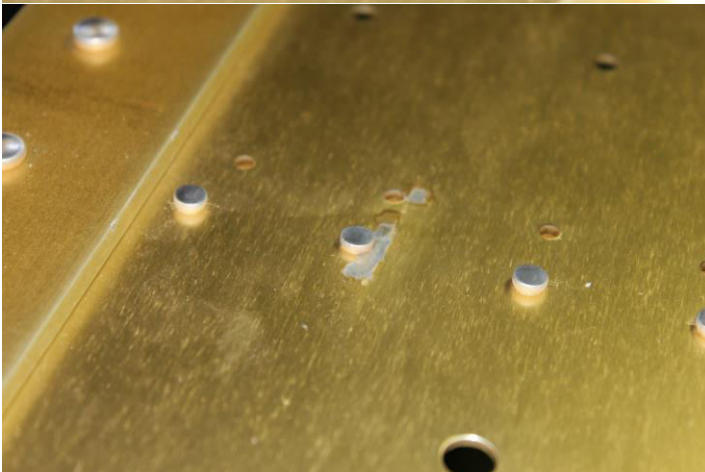
DURING WING RIB TO MAIN SPAR RIVETING THE BUCKING BAR SLIPPED AND CONTACTED SPAR CAUSING A SMALL SCRATCH IN TWO LOCATIONS

- RIB 5 CENTER RIVET
- RIB 9 SECOND RIVET FROM BOTTOM

RIVETS REMOVED SMALL SCRATCHES BLENDED/SPOT ALODINED AND RIVETS REINSTALLED
