# Deviation From Design

**DfD-0023**

**Taran Laval – SAAA Builder 7417  
Van's Aircraft RV7 - 73918**

## RIGHT WING REAR SPAR CORROSION

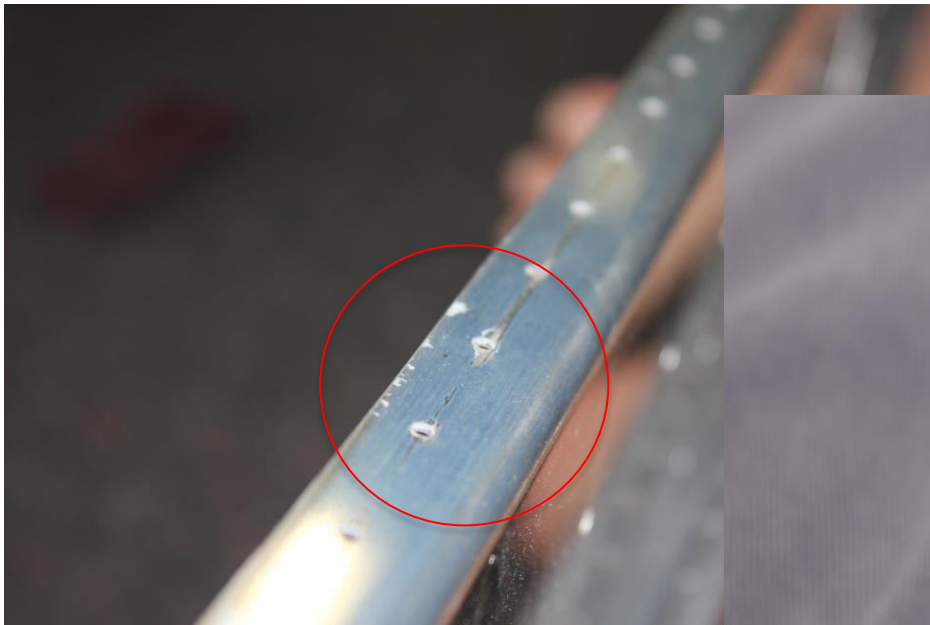
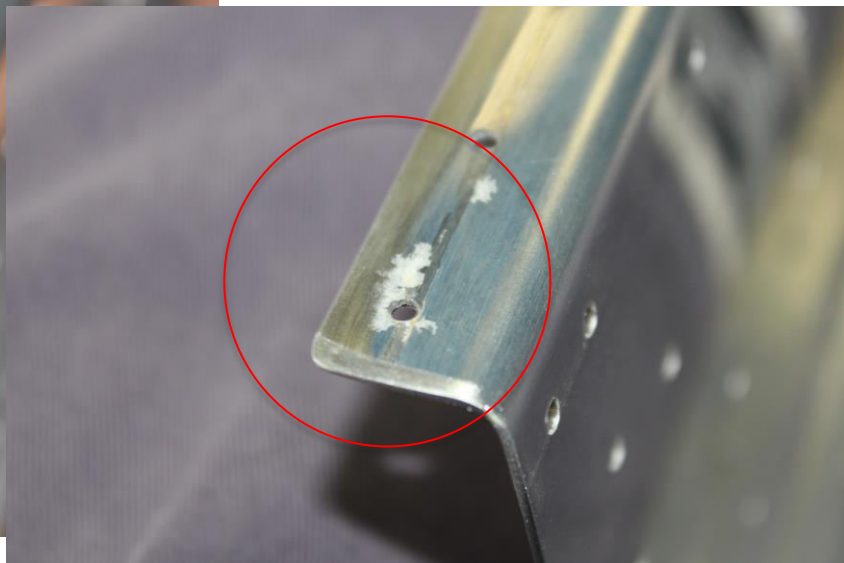
DURING UNPACKAGING OF RIGHT HAND WING REAR SPAR, MULTIPLE SMALL AREAS OF LIGHT SURFACE CORROSION WAS FOUND

- AREAS BLENDED WITH SCOTCHBRITE, ALL CORROSION REMOVED,
- SPAR CHANNEL WILL BE ALUMIPREPPED, ALODINED & PRIMED SHORTLY
- FOLLOW UP INSPECTION TO BE CARRIED OUT DURING ANNUAL CHECKS.
