# Deviation From Design

**DfD-0028**

**Van's Aircraft RV7 – 73918**

## AILERON GAP FAIRING INBOARD RIVET

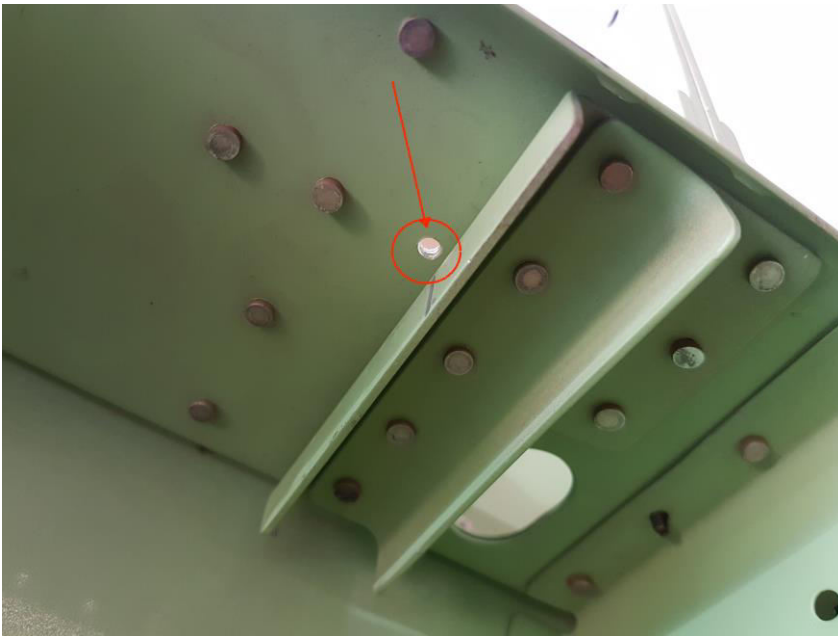
WHEN IT CAME TIME TO RIVET THE AILERON GAP FAIRING TO THE REAR SPAR I FOUND THAT THE INBOARD MOST RIVET COULD NOT BE SET DUE TO INTERFERENCE WITH THE NEWLY INSTALLED DOUBLERS.

I REQUESTED FROM VANS TO INSTALL A BLIND RIVET IN THAT POSITION

VANS AUTHORISED THE USE OF A MSP-42 PULLED RIVET IN THIS LOCATION
