Deviation From Design

DfD :	DfD-0015	Follow Up Required	Taran Laval – SAAA Builder 7417 Van's Aircraft RV7 - 73918
		N

ELEVATOR RHS AFT UPPER HOLE RIVET CHANGE

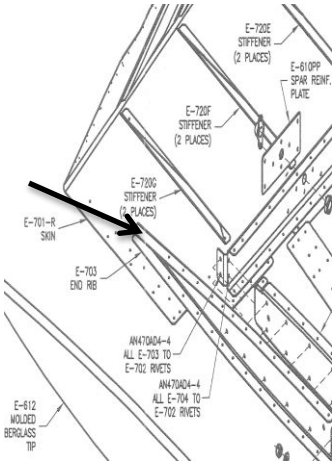
AFT MOST UPPER TIP RIB HOLE INACCESSABLE FOR RIVETING
